REPORTABLE INCIDENTS | WHS MINES LEGISLATION

Weekly incident summary

Published 30 March 2016

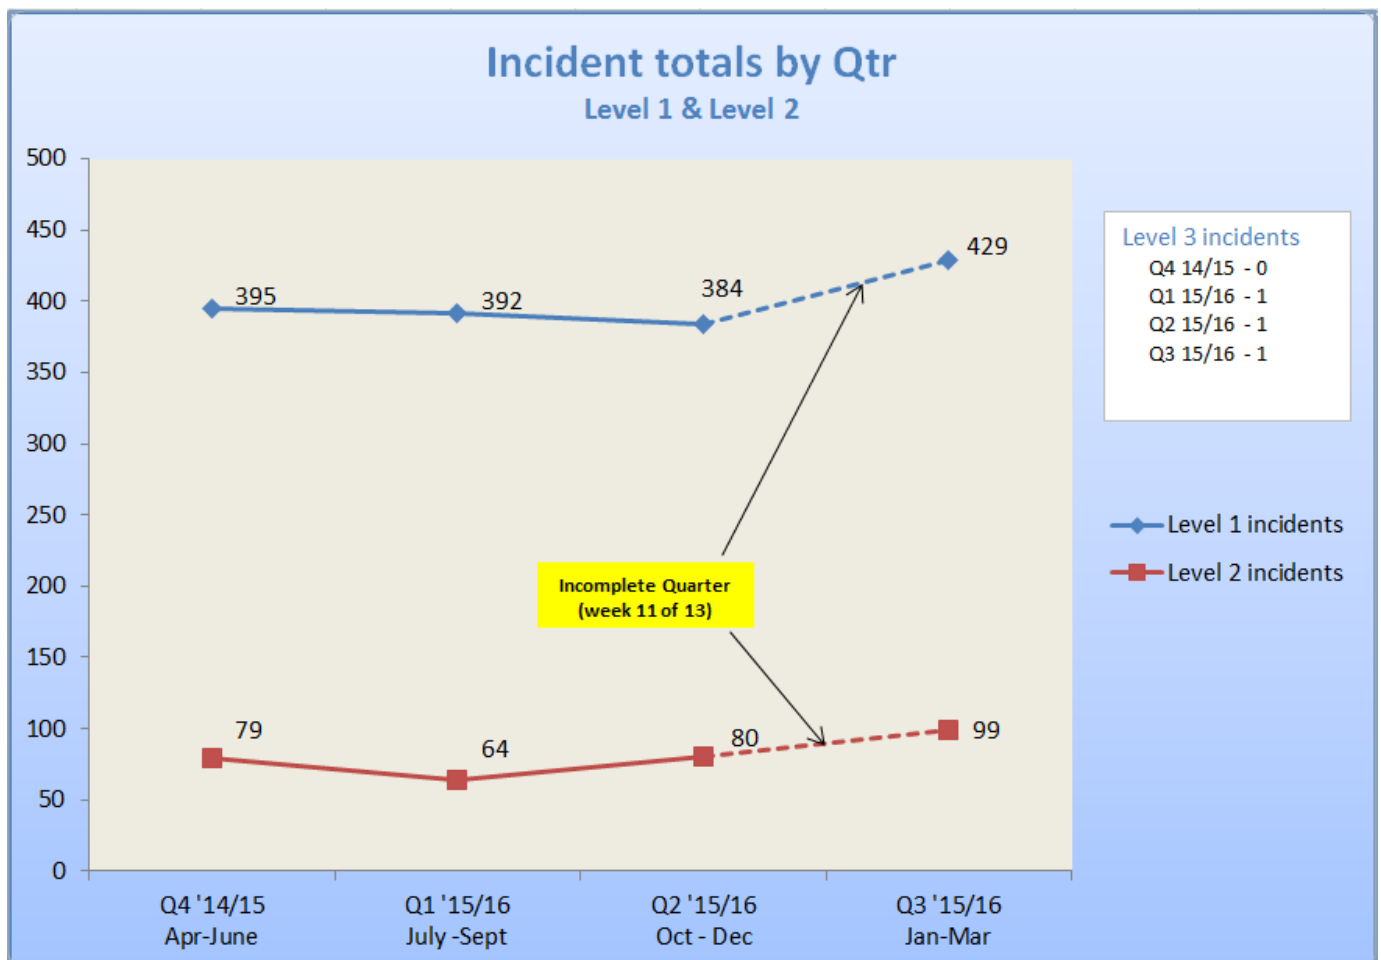
| Level | Incident Type | Summary | Comment to industry |
|---|---|---|---|
| 2 | Strata Ground Control 317659190001 | <p>Approximately 5 tonnes of rock and shotcrete fell onto, and around, the boom of a cable-bolting machine when it commenced grouting 12 cable holes that had been drilled the previous shift. This incident occurred in an underground metalliferous mine in the main decline.</p> <p>The fallen material included steel mesh and resin grouted rock bolts that had been installed when the decline was first developed some 2 years previously. No injuries and minimal damage. The investigation revealed incomplete encapsulation of bolts and a time delay in cable bolt installation after the need for installation of cables was identified.</p> | <p>Mines should ensure that pull test results are analysed and effective action plans are implemented to immediately address any unexpected results. Ground control management plans at underground metalliferous mines may be reviewed with reference to MEX-009 – ‘Mine ground control management plan audit tool’ which is available on the Department’s website at www.resourcesandenergy.nsw.gov.au/miners-and-explorers/safety-and-health/publications/tools</p> |
